Preface

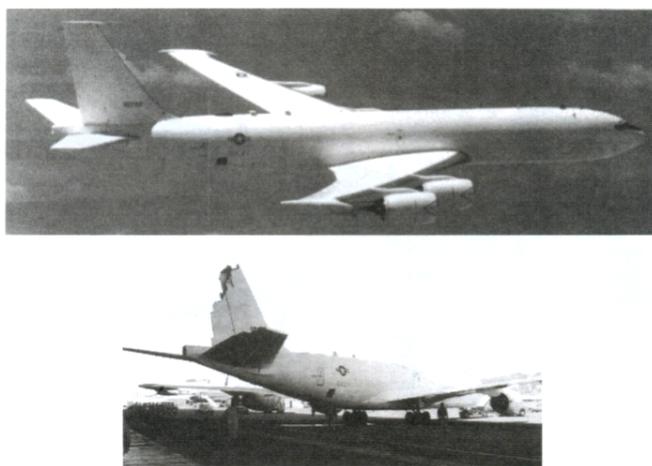
The most recent example which was made public concerns the E-6A aircraft, Navy's version of the Boeing 707-320 airplane. In February 1989, that airplane lost the upper section of the tail fin and the rudder control surface in flight, Figure 1.

Figure 1. *Crash due to flutter on Boeing E-6A tail fin*

The problem was solved by rigidifying the tail fin by extending the spar up to the tail fin tip and reducing the hydraulic pressure in the rudder control surface.

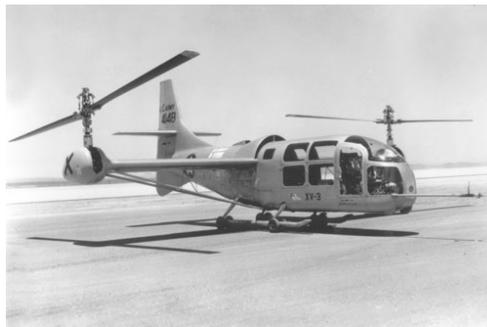
Figure 2. *Bell XV-3 Helicopter with two-blade rotor*

The three-blade hinged rotor was then replaced with a two-blade semi rigid rotor which caused no instability, Figure 2. It should be noted that the struts designed to stiffen the wing were not removed.

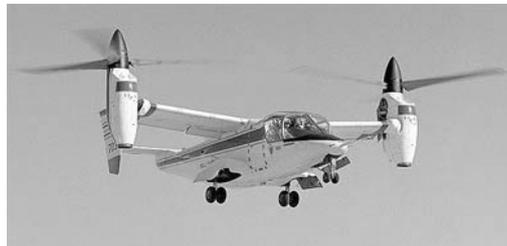
Figure 3. *BELL XV-15 tiltrotor aircraft*

Thus, that failure confirmed the necessity of having very great wing and mast stiffness in order to prevent occurrence of instabilities of the *whirl flutter* type. The continuation of the tiltrotor aircraft development was the contract placed in 1973 to Bell by the NASA and US Army in order to build an industrializable tiltrotor aircraft, XV-15, which in turn led to the V22 built by Bell and Boeing for the US Marine Corps, Figure 3. On those machines, the problem of *whirl flutter* was considered in the design, and the flight tests showed no expression of the phenomenon.

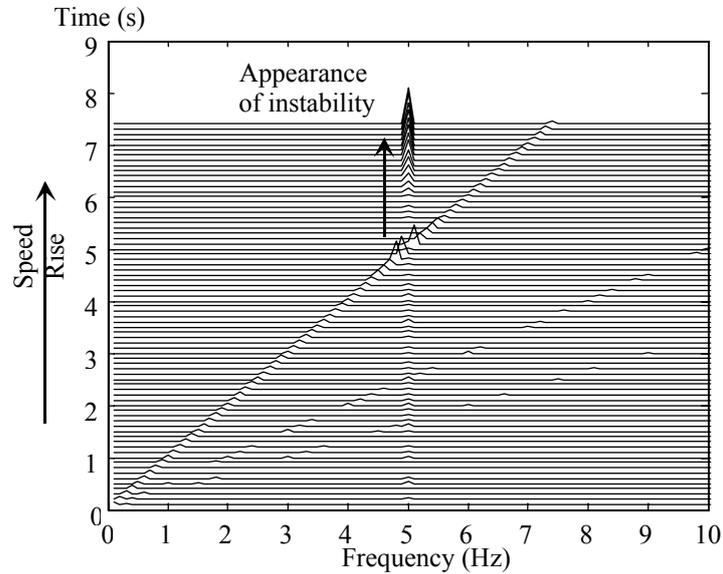
Several years were necessary for the engineers to determine the causes. They also identified that the oil-film bearings of the shaft were a source of instability through a "whipping" phenomenon, Figure 4.

Figure 4. *Frequency spectrum upon starting of a rotating system. Measurement with accelerometer secured to casing. Instability appearance*

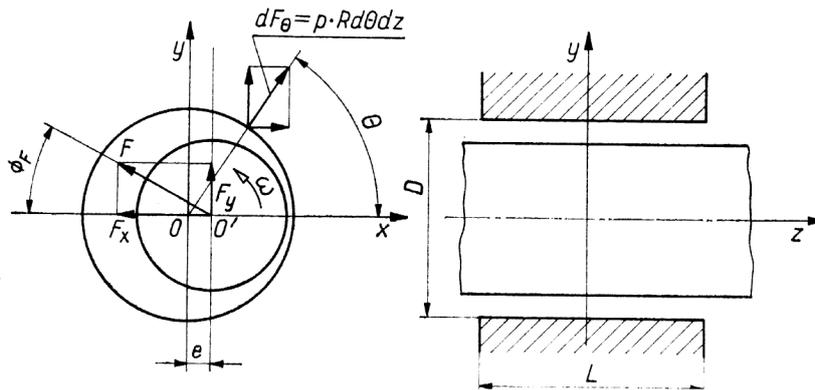
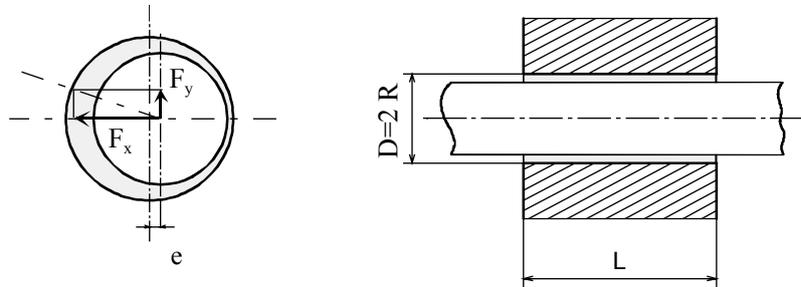
As regards non-supplied bearings, often termed dynamic bearings, the lift of the rotating component is obtained by increasing the pressure between two surfaces moving in relation to each other, as shown in Figure 5.

Figure 5. Schematization of hydraulic bearings

Figure 5. (continued) Schematization of hydraulic bearings

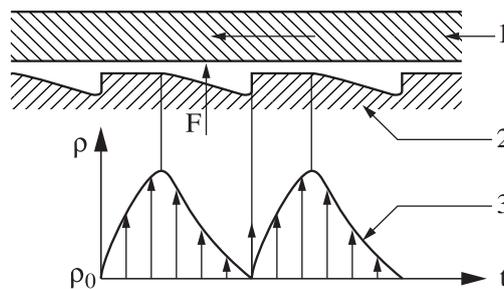
Figure 6. Non-supplied bearing pressure field

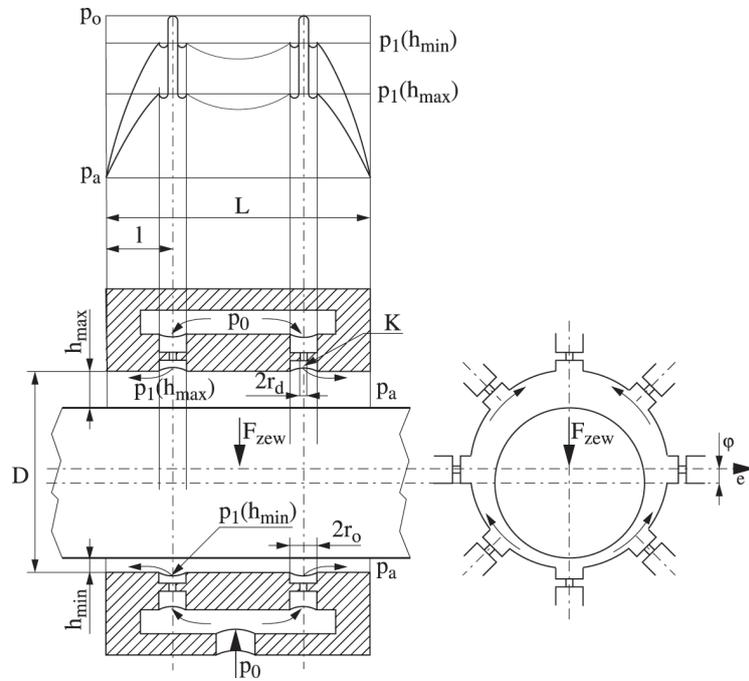
As regards supplied bearings, the lift is given by superimposition of the dynamic effect and the static effect due to the gas pressure related to the external source (Figure 7).

Figure 7. Schematization of supplied bearings

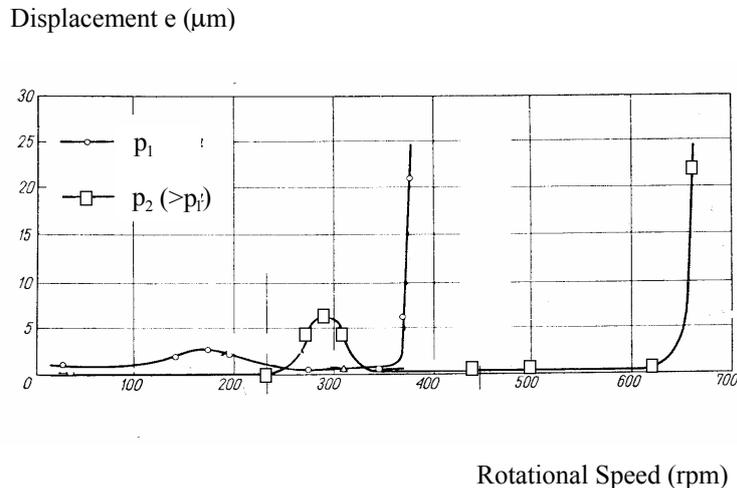
The amplitude of shaft motion in the bearing is given by Figure 8. This figure has been drawn for two supply pressures; two operating areas can be observed:

- a) the amplitude increase in part 1 is caused by the conventional phenomenon of passage through resonance by an unbalanced rotor. Stiffness and damping are caused by the gas film which separates the bearing shaft;
- b) the amplitude increase is very violent (part 2) and results in the shaft stopping moving when contacting the bearing. Such instability is characterized by the shaft precession in the direction of shaft rotation at the eigenfrequency previously mentioned. This frequency is lower than the shaft rotation frequency.

It can be observed that the supply pressure increase from 0.2 MPa to 0.7 MPa moves the instability area from 370 to 630 Hz.

Figure 8. *Dynamic shaft motion versus rotational speed for several supply pressure values*

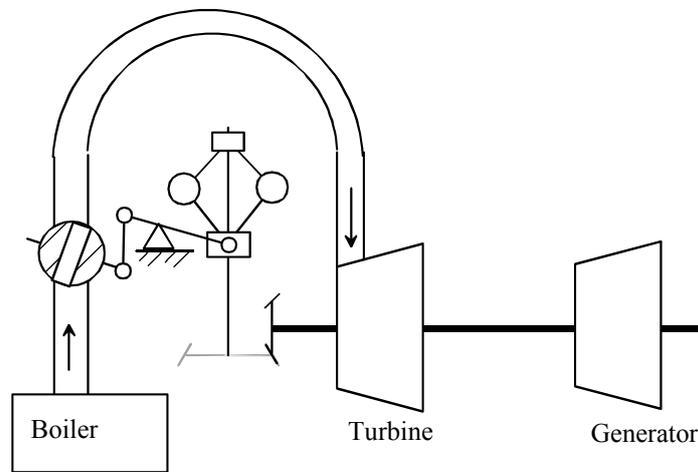
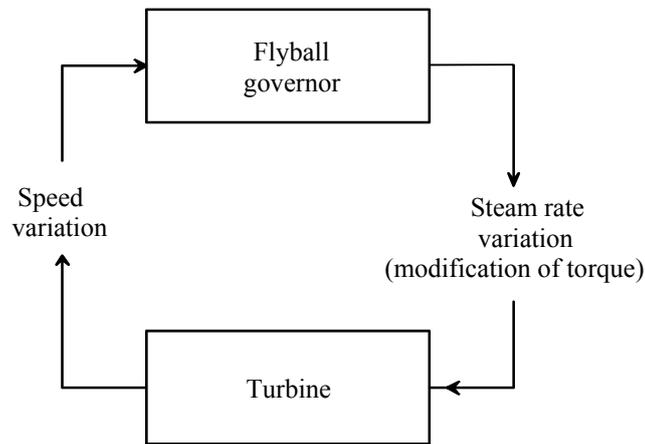
The principle enables conversion of a rotational speed variation into a translational motion. Rods connected the heavy balls to a vertical shaft driven by the steam engine to be controlled.

When the engine ran too fast, the flyballs moved away from each other under the effect of the centrifugal force, the sliding collar on the shaft was raised and acted on the lever which slowed down the engine by reducing the steam inlet.

Figure 9. *Watt's Governor Used to Control the Current Generator - Schematic*

Lenoir also used such mechanism to adjust the flow rate of the fuel mixture supplying his engine. Problems of oscillations were encountered on the first current generators where the Watt's governor was used to govern the speed.

Such phenomenon, termed *hunting* [HAR 95], led to fluctuation of the light produced, visible to the naked eye.
